Third Five-Year Review Report **Solid State Circuits** Republic Greene County, Missouri

September 2007

Region 7 **United States Environmental Protection Agency** Kansas City, Kansas

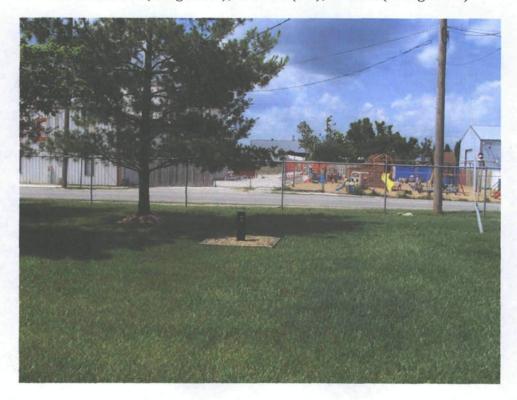
While there have been no changes in the SSC site conditions that create new exposure pathways, a daycare center is now located immediately north of the treatment building across East Elm Street. This brings a sensitive receptor population near the SSC site and creates a potential for outdoor air exposure. An evaluation of the discharge height for the air stripper was completed to determine if there is a potential for impacting the center. To ensure VOC emissions from groundwater treatment will not result in an exposure pathway at the daycare center, the treatment facility now only pumps the most contaminated wells at night. The nightly pumping is sufficient to maintain the requirements set forth in the CD/SOW.

Well SSC – 9 with Daycare in Background

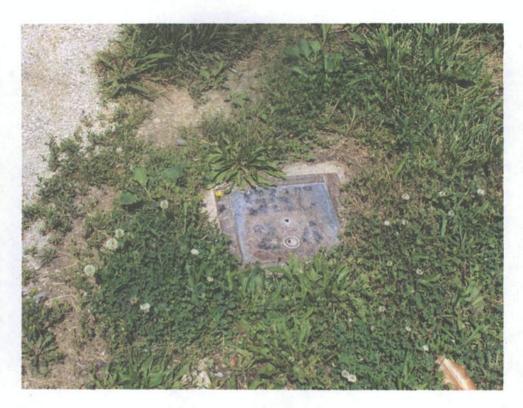
Well SSC-24: note faded label

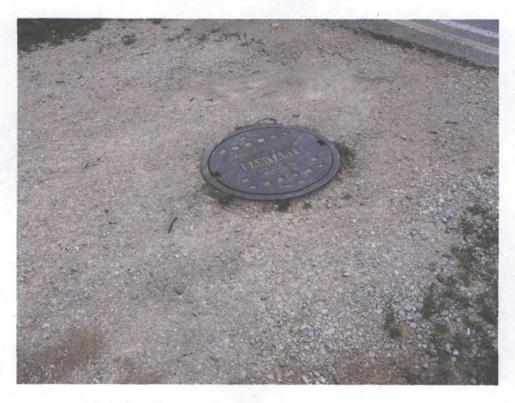
Well SSC-30: note no identification label on well cover

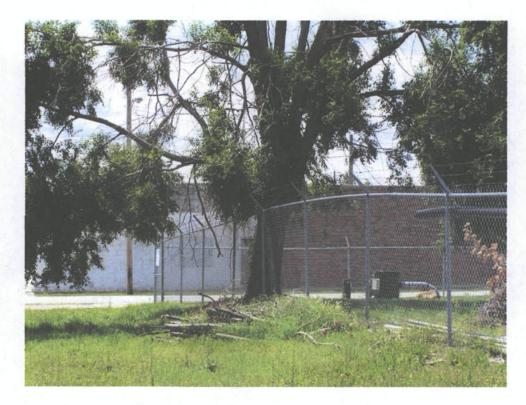
Controls such as fencing, warning signs, and well locks are in place. These controls prevent casual access to the treatment facility and other components of the RA. Access to extracted groundwater is restricted to authorized plant operators and other personnel. Although these controls are in good condition, there is a large tree within the site fence with a low hanging branch extending outside the fence. This simplifies access to the SSC site by vandals. Removing the low hanging branch would eliminate this problem. No other actions appear necessary.

Site Fencing - note tree overhanging fence
